## **ASSET MANAGEMENT PLAN**

**TOWN OF ABERDEEN, SK**

# Town of Aberdeen | Asset Management Plan

Updated February 2019

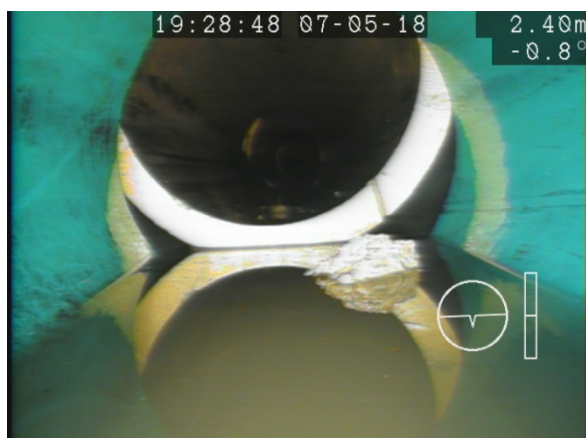
Figure 6: Major Offset (2.4m from MH 18 towards MH 17)

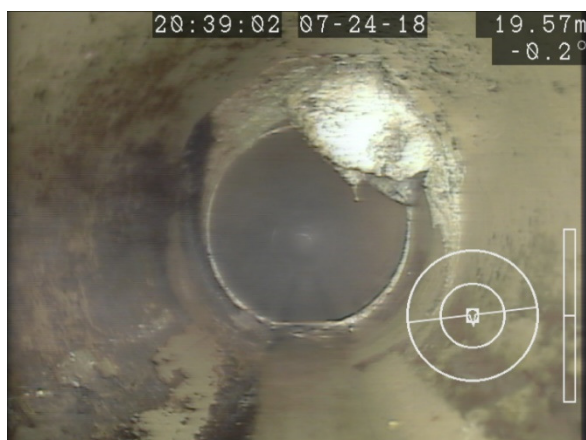
Figure 9: Over-extended Service with Calcite Buildup (19.6m from MH 23 towards MH 24)

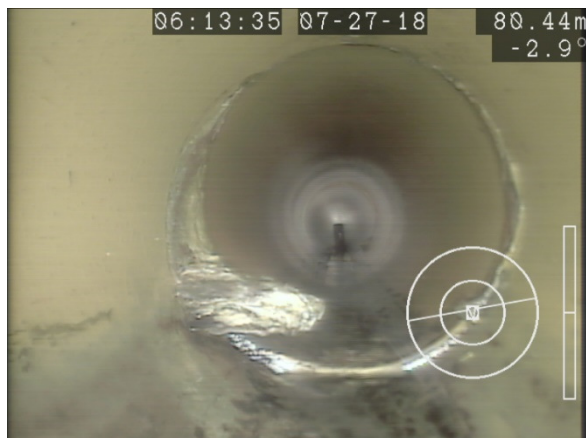
Figure 11: Calcite Buildup (80.5m from MH 43 towards MH 19)

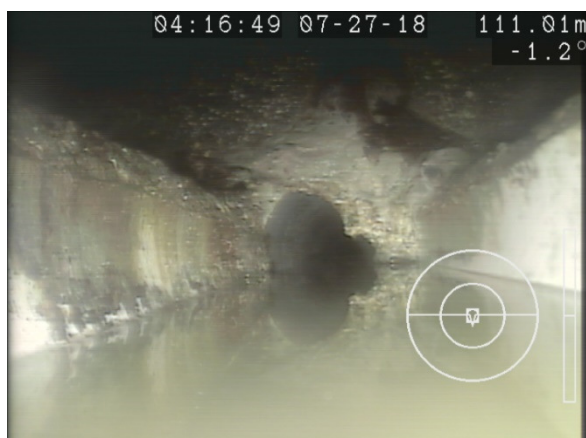
Figure 12: Calcium Buildup (MH 44)

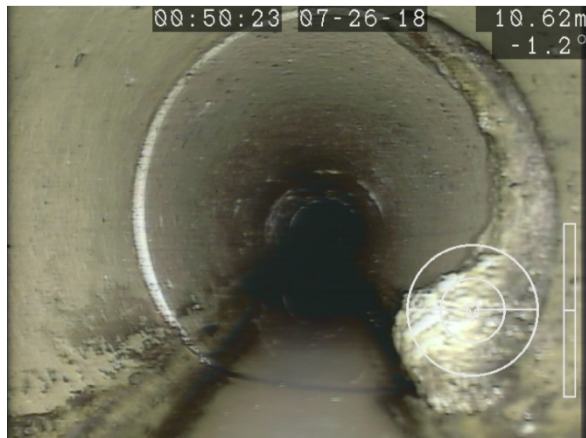
Figure 16: Calcite Buildup (10.6m from MH 31 towards MH 32)

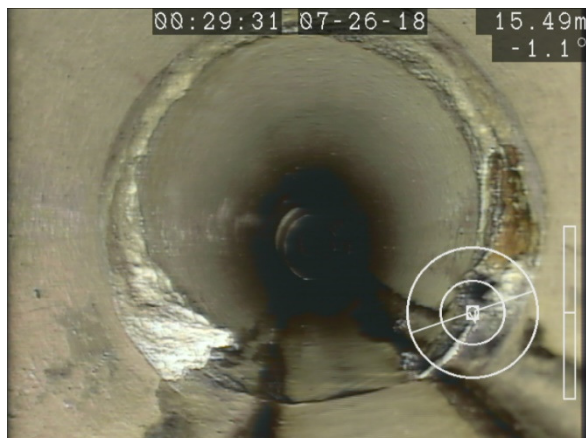
Figure 17: Calcite Buildup (15.5m from MH 32 towards MH 31)

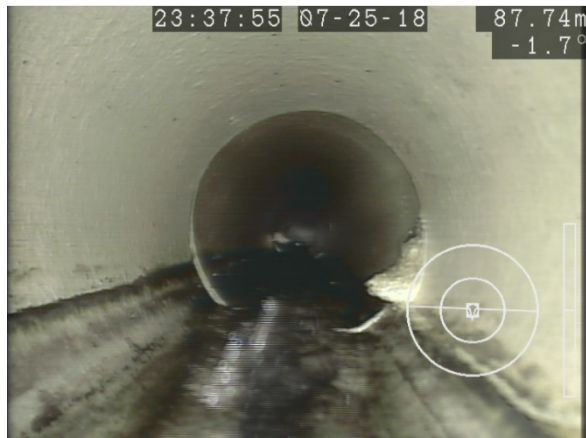
Figure 19: Calcite Buildup (87.74m from MH 33 to MH 32)

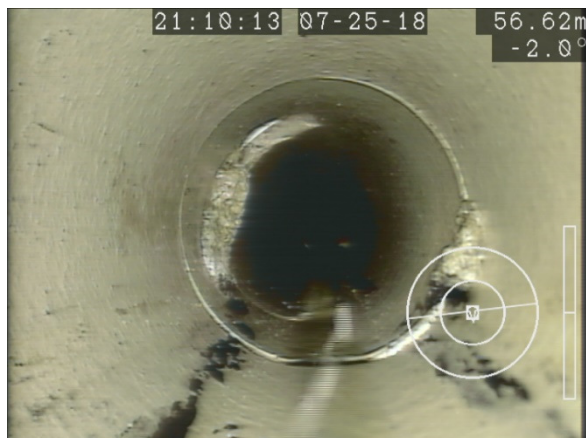
Figure 20: Calcite Buildup (56.6m from MH 34 towards MH 42)

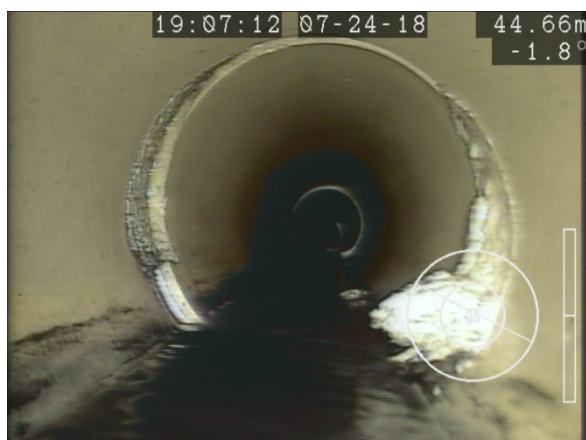
Figure 24: Calcite Buildup (44.66m from MH 28 towards MH 27)

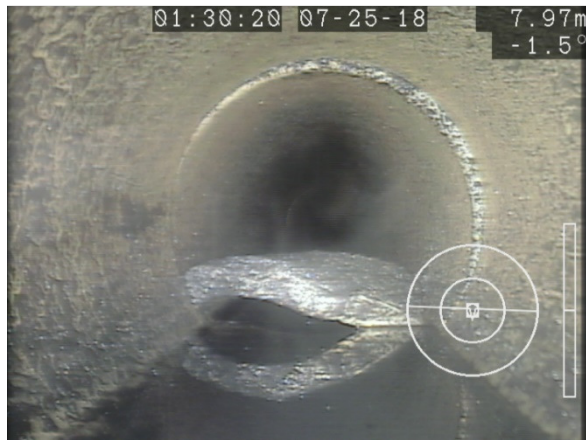
Figure 28: Broken Clay Pipe Piece (8m from MH 40 to MH 41)

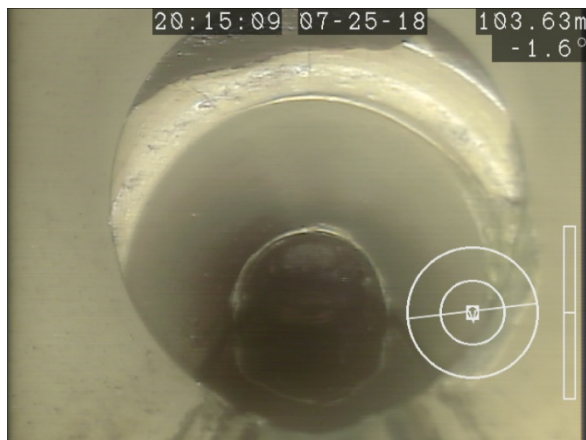
Figure 29: Offset in Pipe Just Outside Manhole (MH 35)

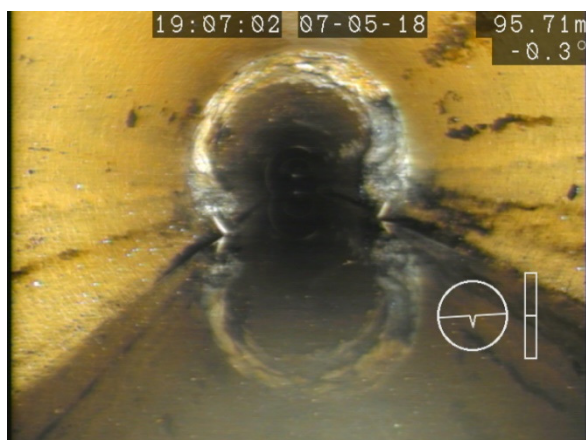
Figure 30: Calcite Buildup (95.71m from MH 18 to MH 29)

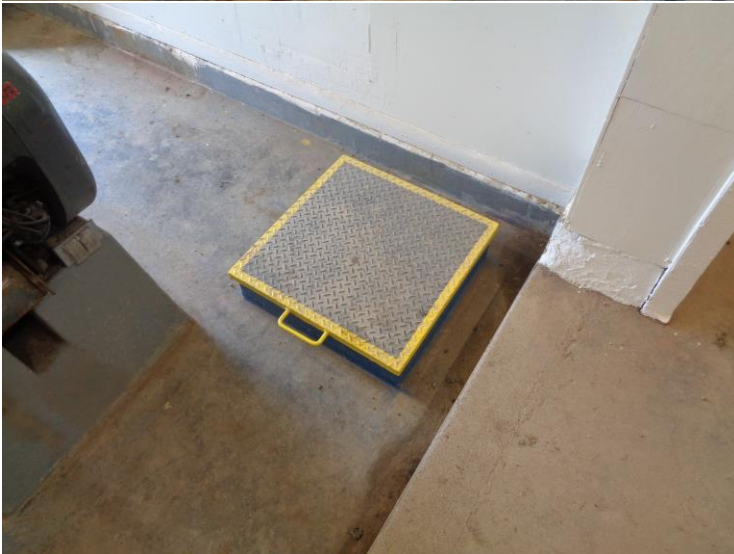
**Photo 5**

Reservoir No. 1 access – curb height extended to 150 mm
