Version 2: April 2022

ASSET MANAGEMENT PLAN

PREPARED FOR:

TOWN OF ABERDEEN, SK

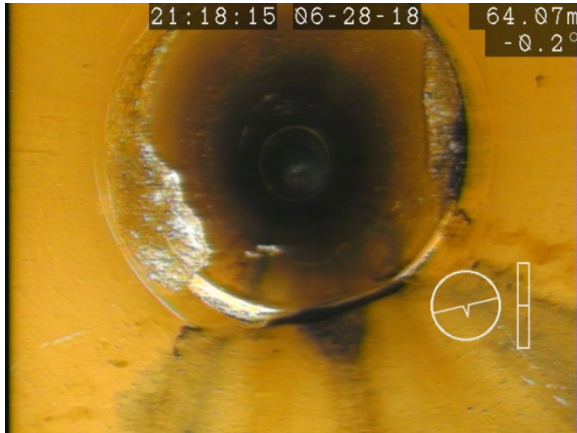
Figure 1: Calcite Buildup Blocking Camera (64m from MH 7 towards MH 6))

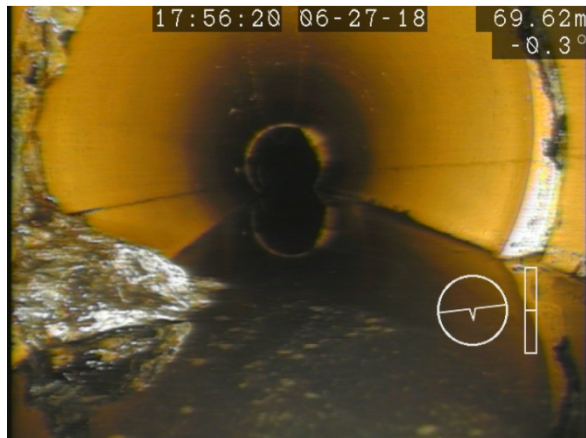
Figure 4: Calcite Buildup (69.62m from MH 16 towards MH 17)

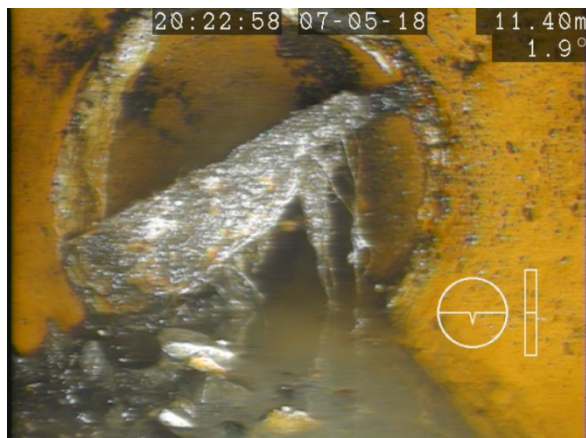
Figure 5: Large Debris Lodged in Pipe (11.4 m from MH 17 toward MH 18)

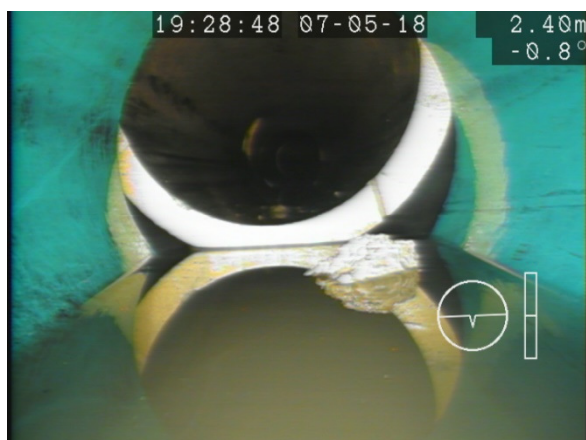
Figure 6: Major Offset (2.4m from MH 18 towards MH 17)

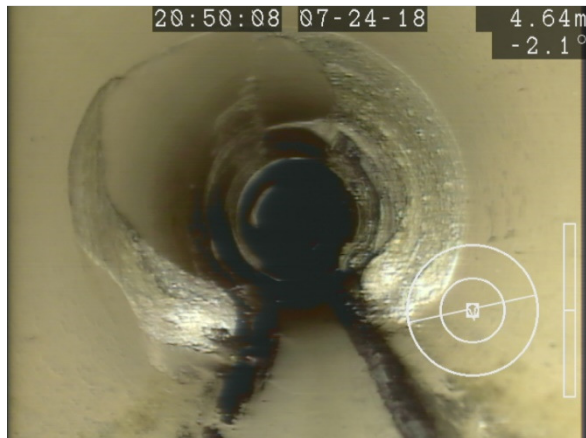
Figure 7: Calcite Buildup (4.6m from MH 23 towards MH 22)

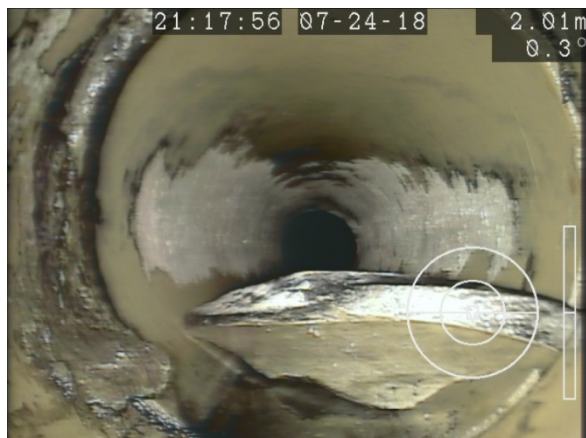
Figure 8: Broken Piece of Clay Pipe (MH 22)

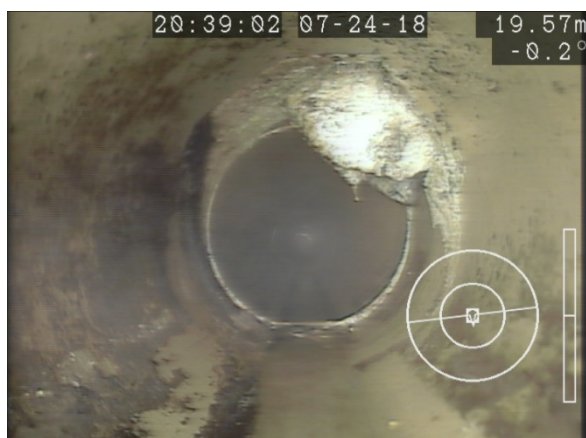
Figure 9: Over-extended Service with Calcite Buildup (19.6m from MH 23 towards MH 24)

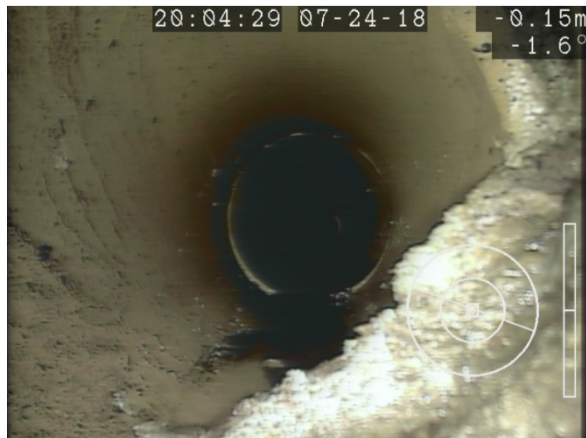
Figure 10: Calcite Buildup (at MH 24)

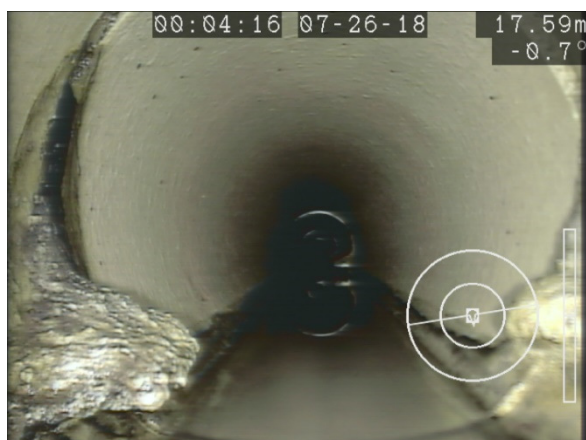
Figure 18: Calcite Buildup (18m from MH 32 towards MH 33)

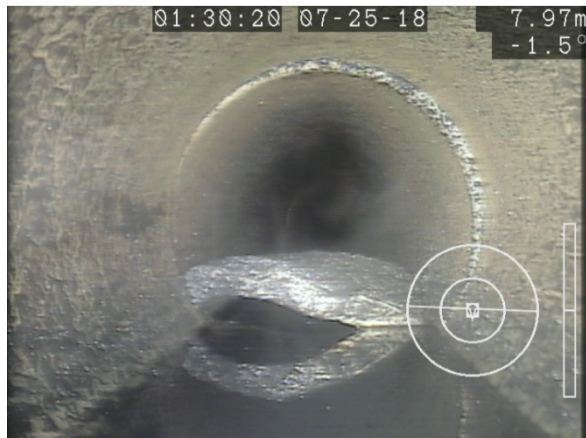
Figure 28: Broken Clay Pipe Piece (8m from MH 40 to MH 41)

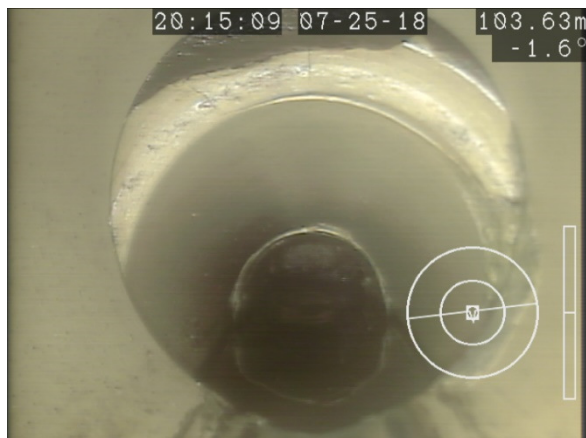
Figure 29: Offset in Pipe Just Outside Manhole (MH 35)

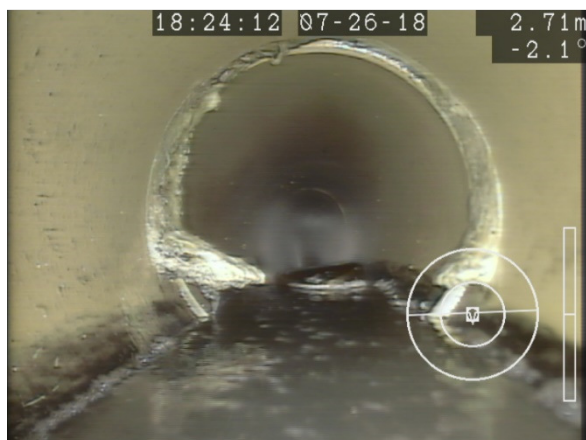
Figure 34: Calcium Buildup (2.7m from MH 35 towards MH 31)

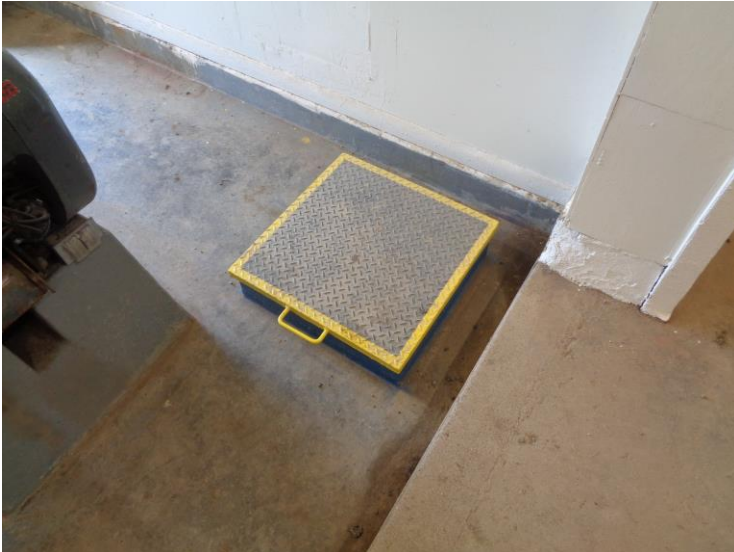
Photo 5

Reservoir No. 1 access – curb height extended to 150 mm

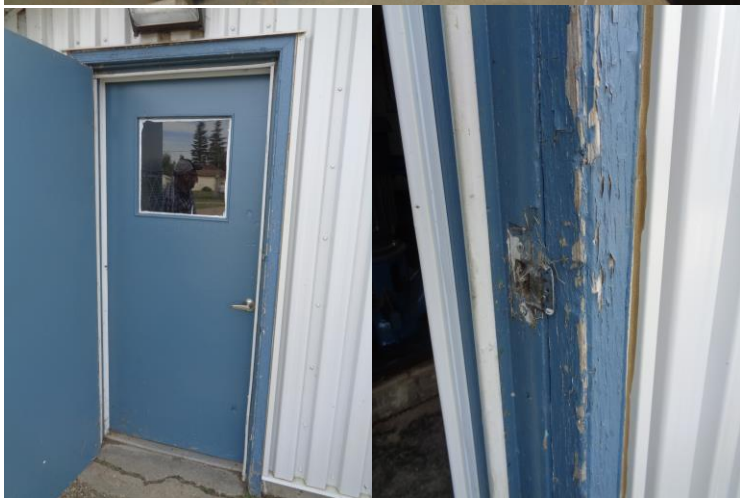
Photo 15
Building access to original portion of building
- Rotten door frame (right)
