## **ASSET MANAGEMENT PLAN**

**TOWN OF ABERDEEN, SK**

# Town of Aberdeen | Asset Management Plan

Updated February 2019

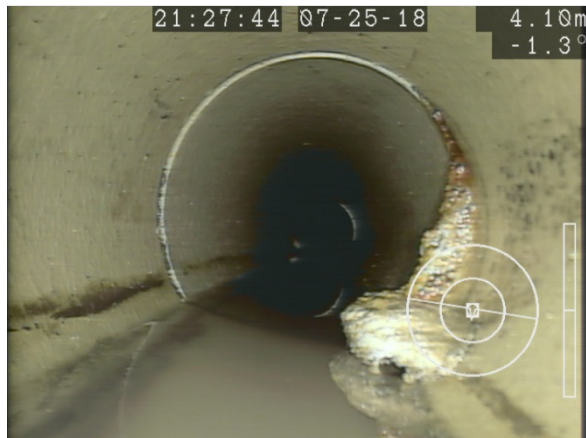
Figure 22: Calcite Buildup (4.1m from MH 42 towards MH 34)

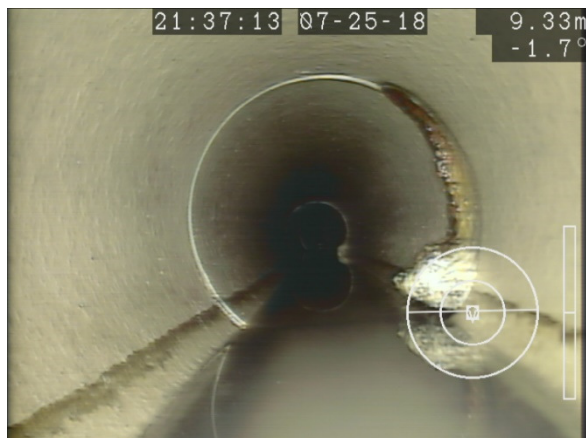
Figure 23: Calcite Buildup (9.33m from MH 42 towards MH 38)

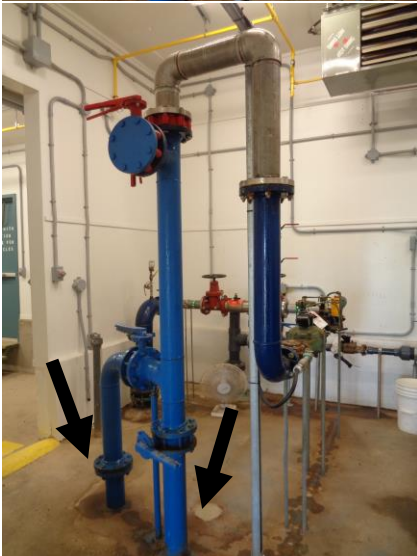
**Photo 2**

Incoming water is discharged to the far side Reservoir No. 2 (Photo 2), flows through the reservoir to the connecting pipe to Reservoir No. 1. The water then flows across Reservoir No. 1 to the distribution pumps.

Discharge to reservoirs

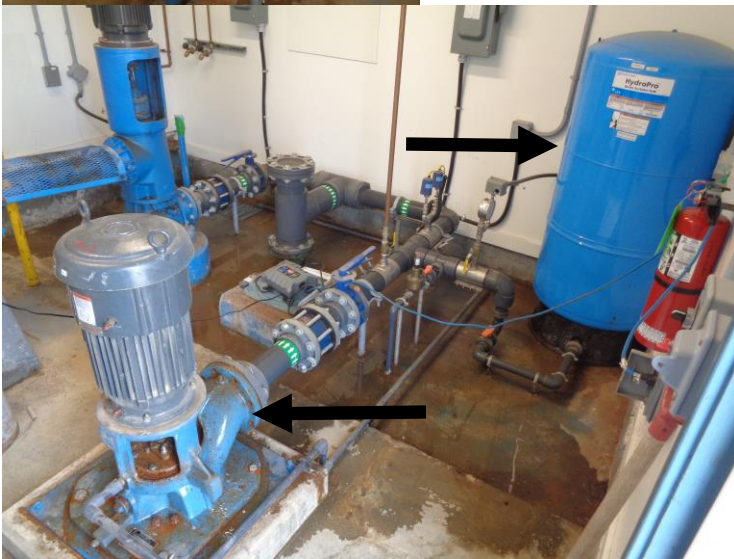
**Photo 3**

Pump No. 1 (Photo 3) was installed with the recent upgrades. Both pumps received new 10 hp motors at the same time.

Distribution Pump No. 1  
(left) and hydro  
pneumatic tank (right)

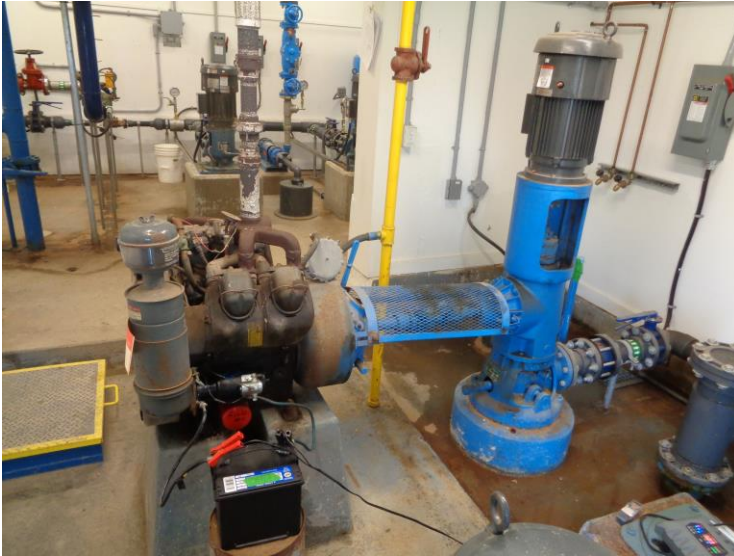
**Photo 4**

Pump No. 2 (Photo 4) can be driven by either electric motor or by a natural gas engine. When needed, the engine drive is manually operated at a greater RPM than the electric motor to supply more water. SaskPower conducted a review of the natural gas engine and placed an "Unsatisfactory Condition Report" tag on the engine. It notes that the engine is not CSA approved, exhaust piping is leaking CO<sub>2</sub> at 32 ppm, parts are obsolete, and replacement is recommended.

Pump No. 2 (electric and engine driven standby)

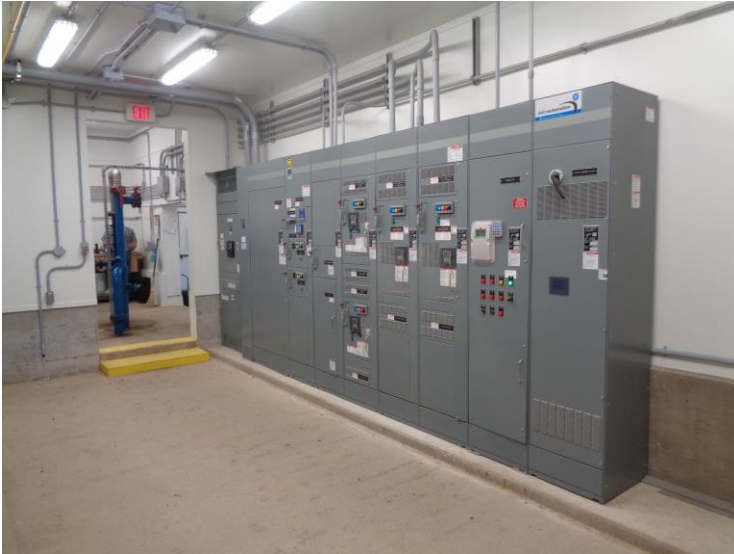
The recently expanded area of the pumphouse houses upgraded electrical (Photo 8) and provides space for a future standby (fire) pump and standby power generator.

**Photo 8**  
Upgraded electrical

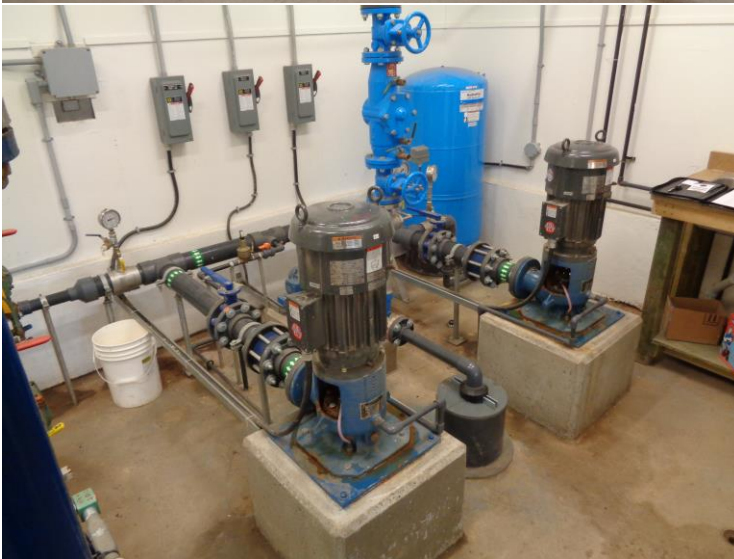
The WPH is equipped with two distribution pumps. There are also two distribution pumps that supply the Highway 41 Utility (Photo 9) which are owned and operated by the Utility. These two pumps do not supply water to the Town. A summary of the pumps available to the Town's distribution system are shown in Table 8.1.

**Photo 9**  
Highway 41 Utility  
distribution pumps

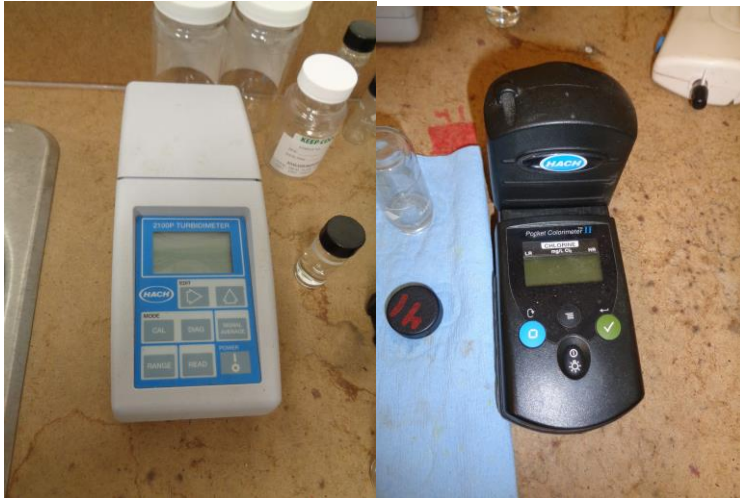
The Town has a Hach Pocket Colorimeter II (total and free chlorine) and a Hach 2100P Turbidimeter (Photo 13). Both pieces of equipment are in good condition and calibration checks are done regularly. The Town tests regularly for both chlorine and turbidity. Work bench space within the plant is minimal (Photo 14).

**Photo 13**  
Water testing equipment
