Version 2: April 2022

ASSET MANAGEMENT PLAN

PREPARED FOR:

TOWN OF ABERDEEN, SK

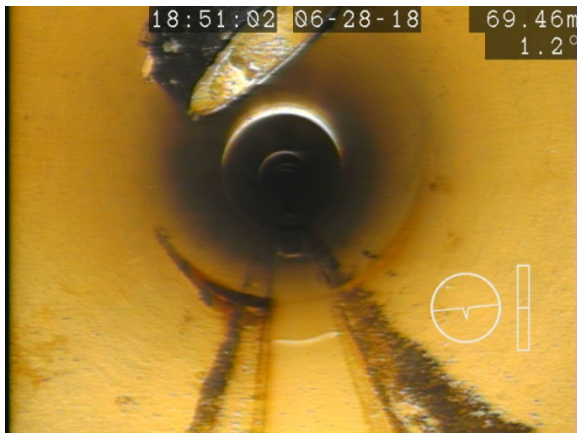
Figure 2: Extended Service (69.5m from MH 9 towards MH 10)

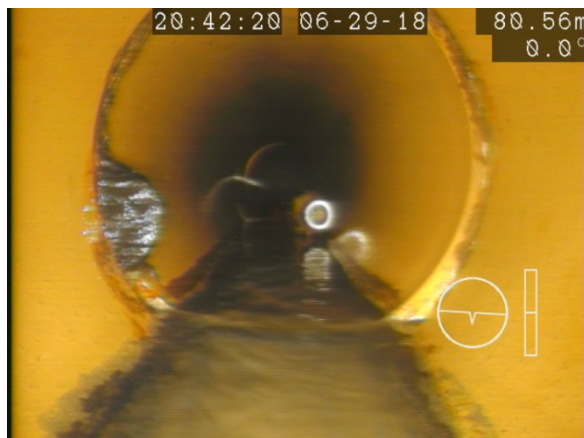
Figure 14: Calcite Buildup (81m from MH 4 towards MH 3)

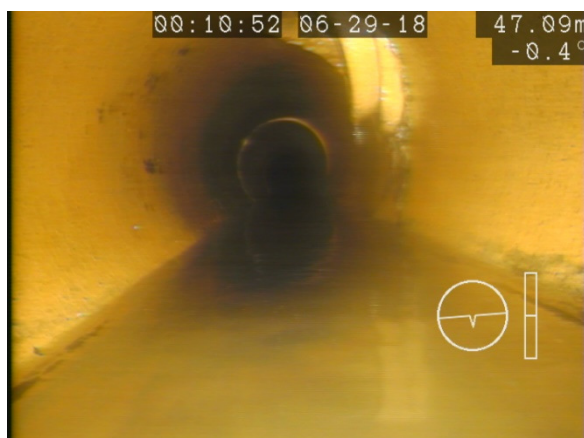
Figure 15: Calcite Buildup (47.1m from MH 5 towards MH 4)

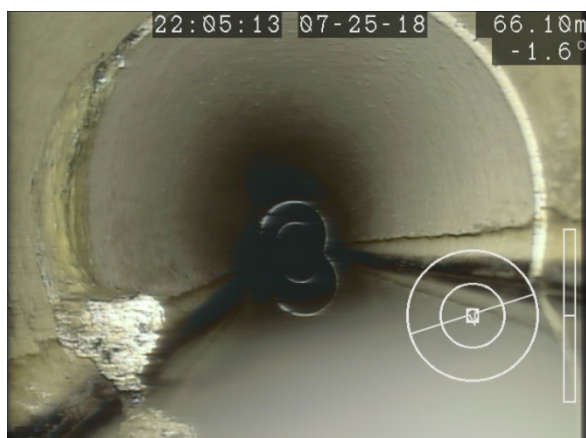
Figure 20: Calcite Buildup (56.6m from MH 34 towards MH 42)

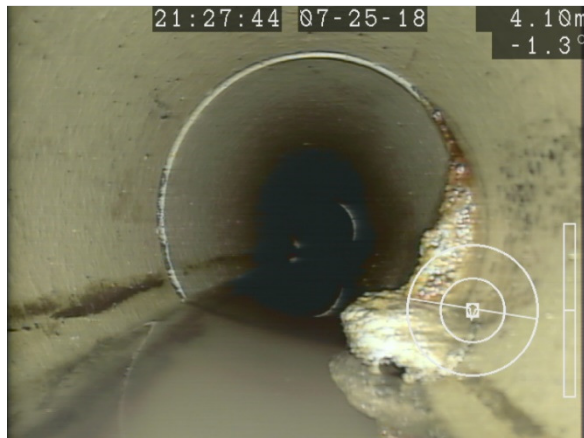
Figure 21: Calcite Buildup (66.1m from MH 38 towards MH 42)

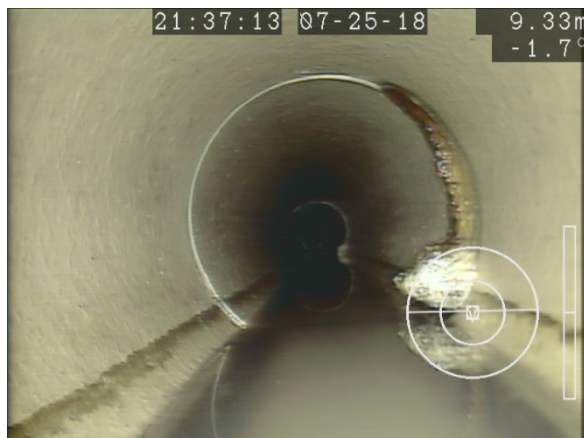
Figure 22: Calcite Buildup (4.1m from MH 42 towards MH 34)

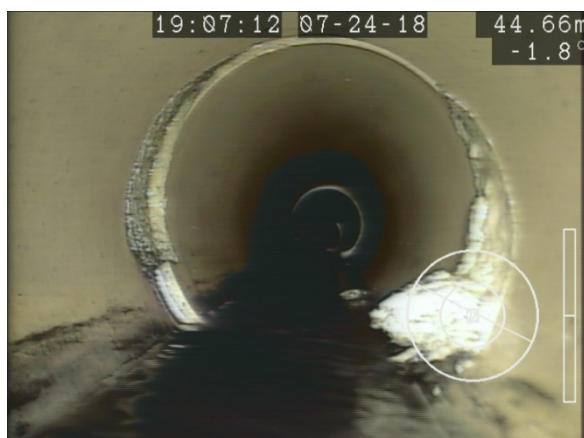
Figure 23: Calcite Buildup (9.33m from MH 42 towards MH 38)

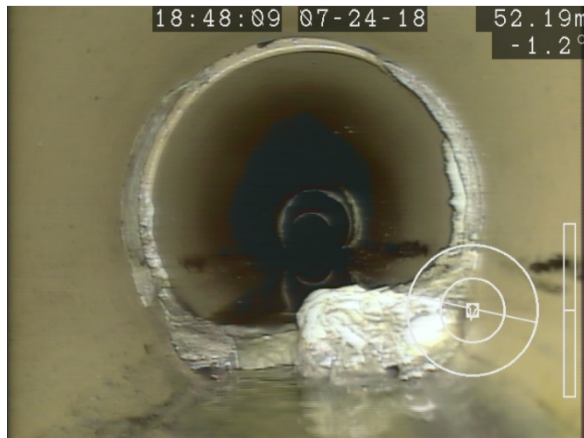
Figure 24: Calcite Buildup (44.66m from MH 28 towards MH 27)

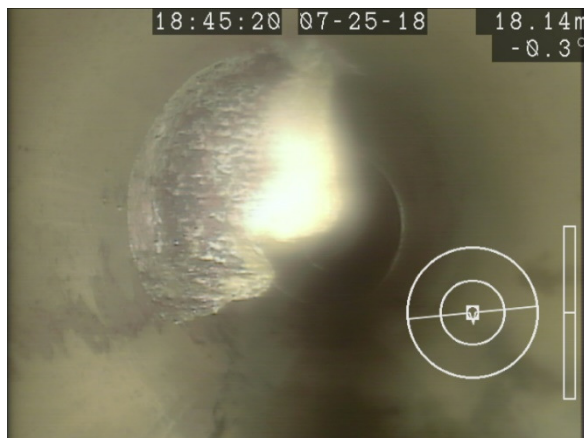
Figure 25: Calcite Buildup (55m from MH 28 towards MH 29)

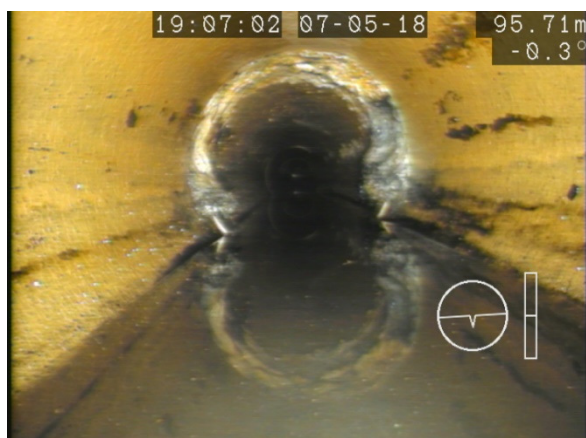
Figure 29: Offset in Pipe Just Outside Manhole (MH 35)

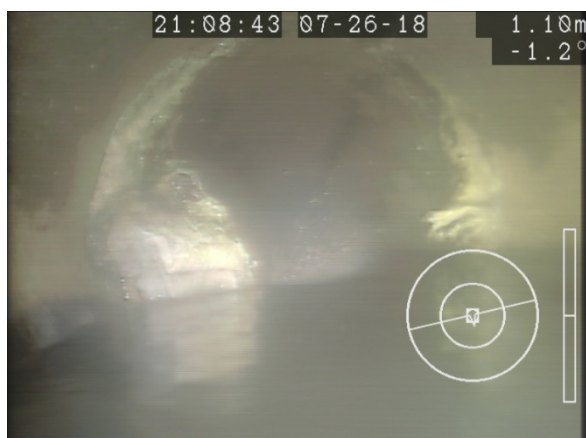
Figure 32: Calcite Buildup (3.75m from MH 22 towards MH 19)

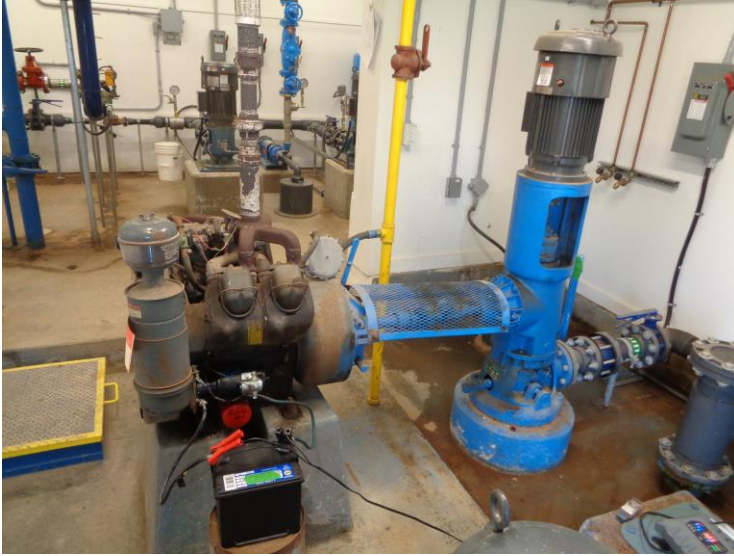
Photo 4

Pump No. 2 (Photo 4) can be driven by either electric motor or by a natural gas engine. When needed, the engine drive is manually operated at a greater RPM than the electric motor to supply more water. SaskPower conducted a review of the natural gas engine and placed an "Unsatisfactory Condition Report" tag on the engine. It notes that the engine is not CSA approved, exhaust piping is leaking CO₂ at 32 ppm, parts are obsolete, and replacement is recommended.

Pump No. 2 (electric and engine driven standby)

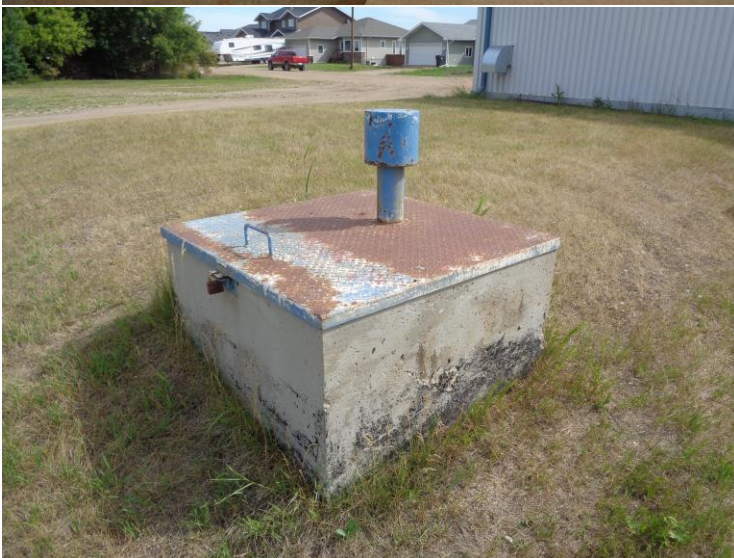
Photo 6

The steel cover for the access to Reservoir No. 2 is outside and set on a concrete curb, which is approximately 150 mm above the adjacent grade. The most recent EPO report indicated that the gasket at the access hatch required replacement. The Town must ensure that the access is properly sealed. The exterior reservoir access is locked, and the reservoir vent is protected with an insect screen (Photo 6).

Reservoir No. 2 – exterior access

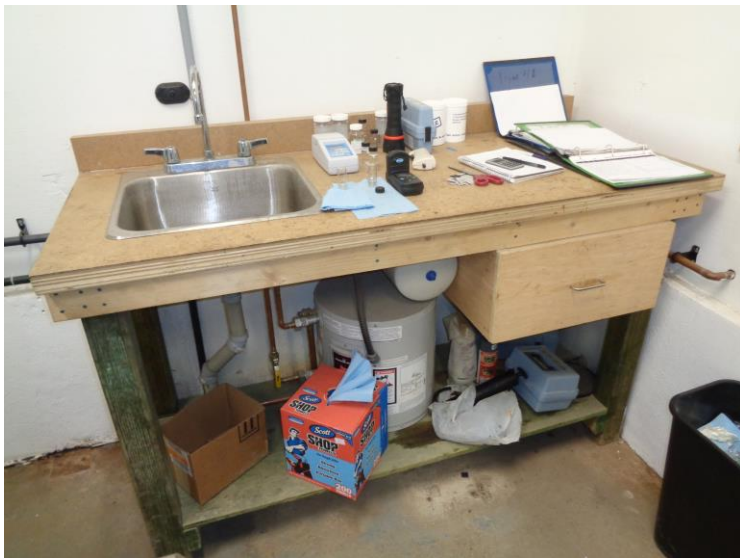
The Town has a Hach Pocket Colorimeter II (total and free chlorine) and a Hach 2100P Turbidimeter (Photo 13). Both pieces of equipment are in good condition and calibration checks are done regularly. The Town tests regularly for both chlorine and turbidity. Work bench space within the plant is minimal (Photo 14).

Photo 14
Work bench space
